M/V LECONTE UNIFIED COMMAND AFTER ACTION REPORT

Unified Command
After Action Report

M/V LECONTE Response

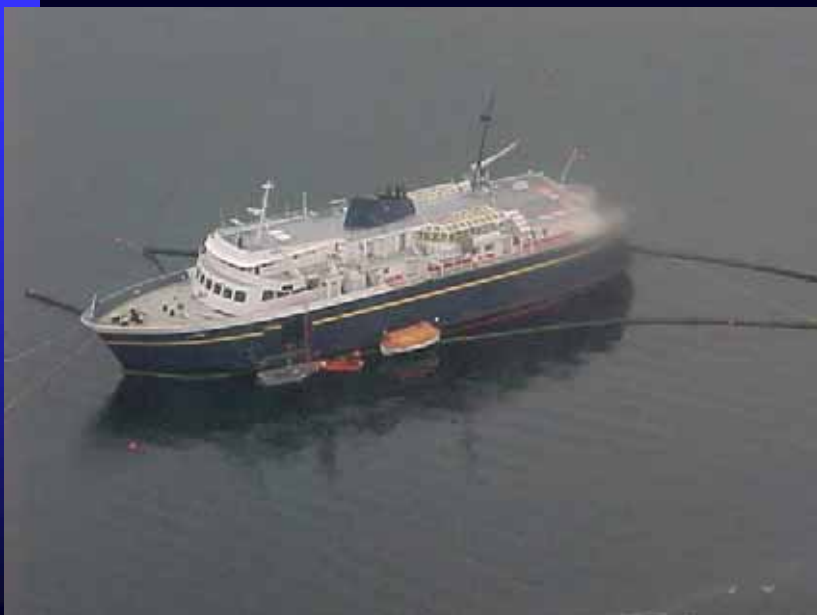
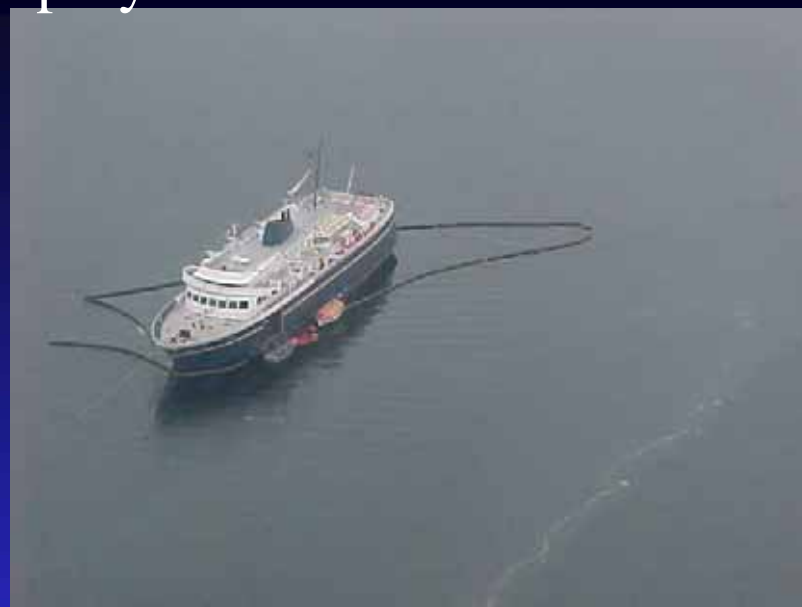
Boom Deployment

- Vessel surrounded by boom - approximately 1000 ft
- Vehicles removed from ferry onto Landing Craft
- Fuel Lightered to Landing Craft – approximately 23,000 Gallons

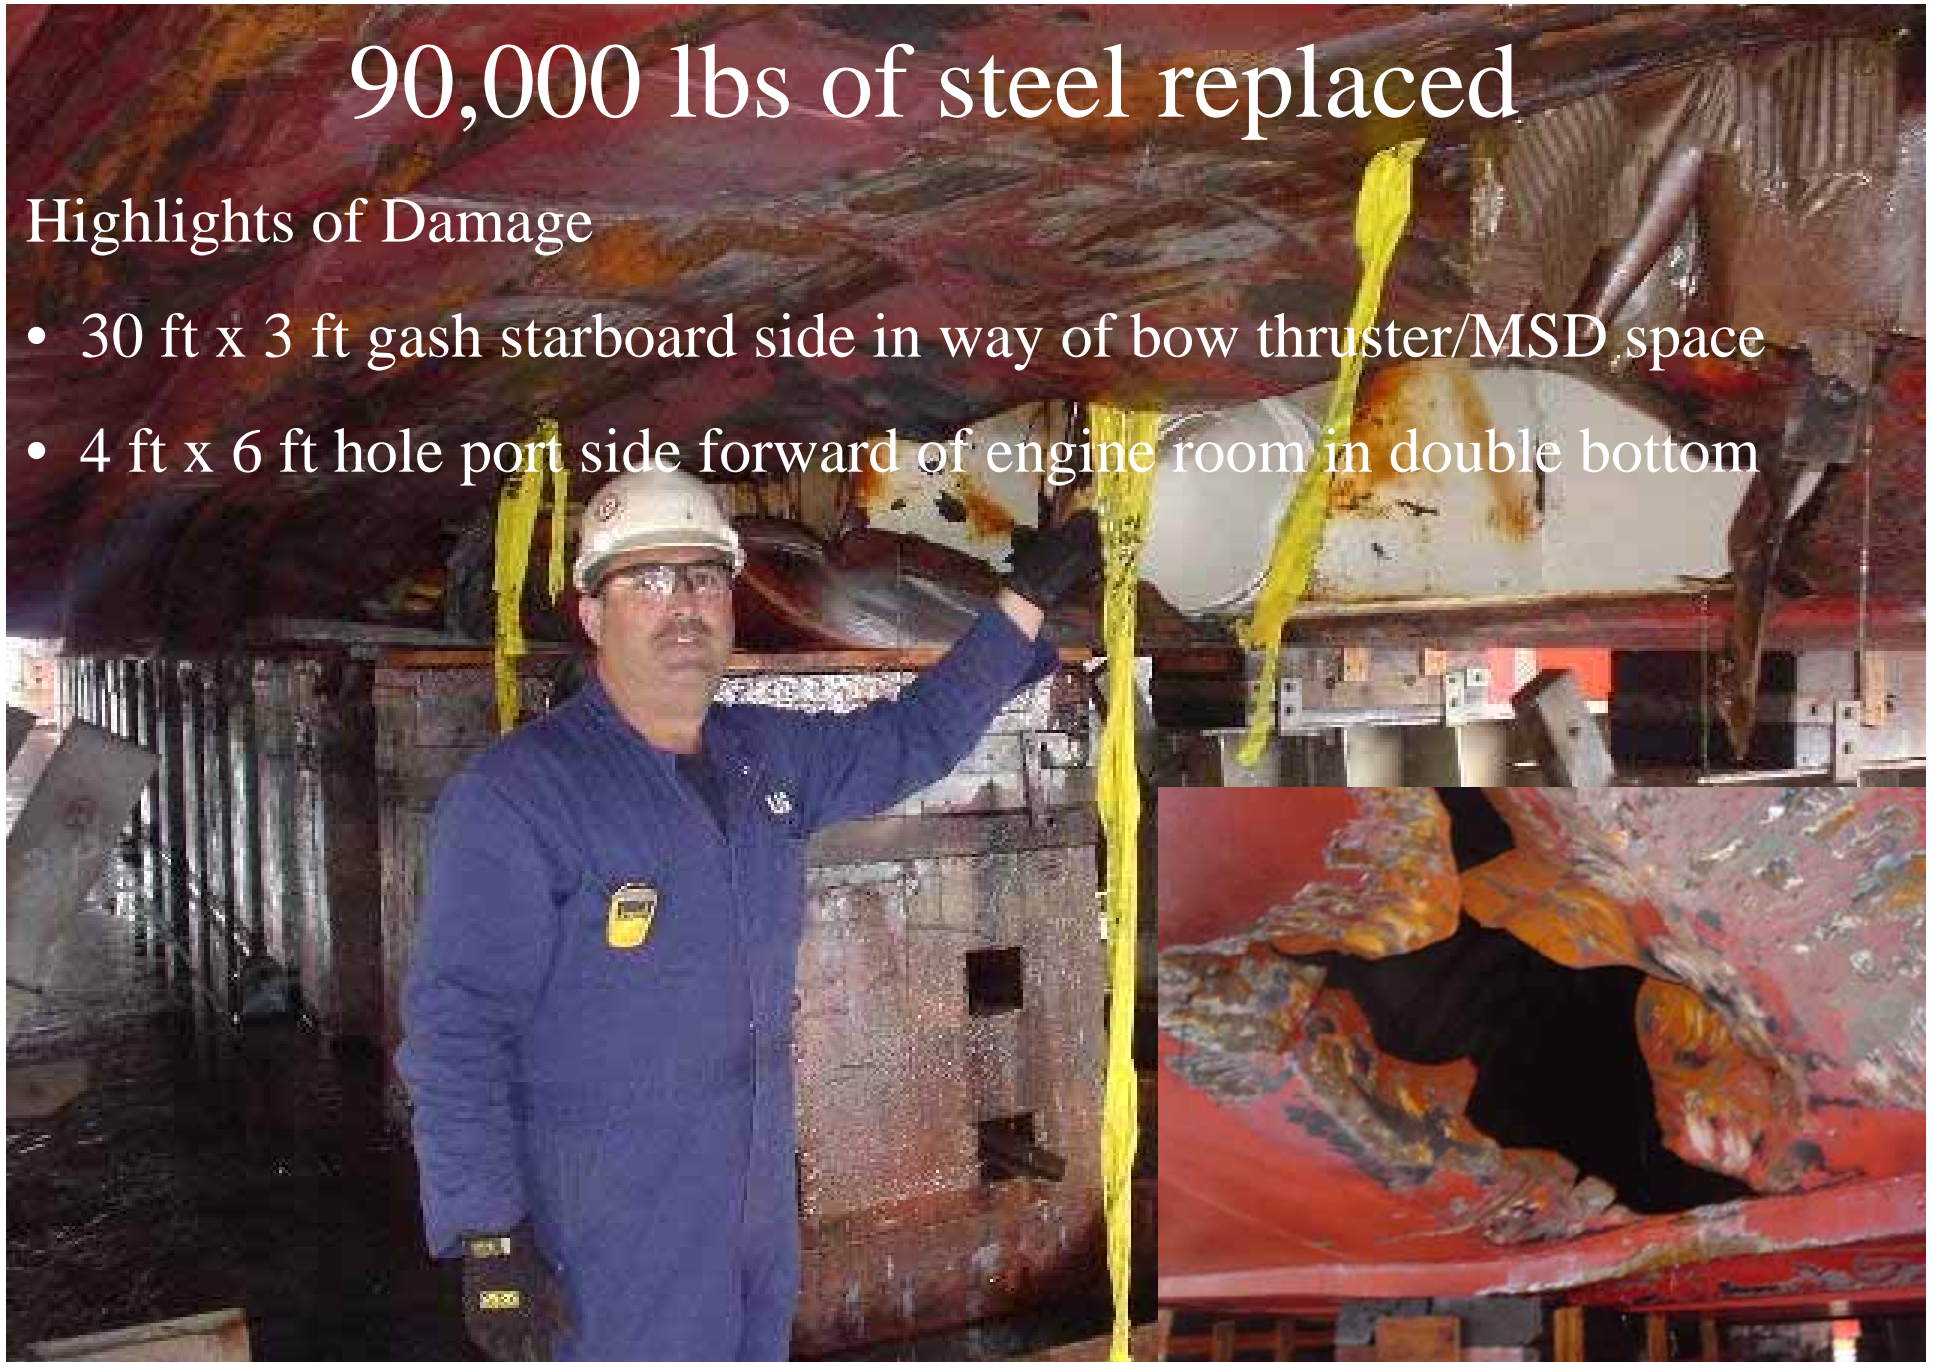
Highlights of Damage

90,000 lbs of steel replaced

- 30 ft x 3 ft gash starboard side in way of bow thruster/MSD space
- 4 ft x 6 ft hole port side forward of engine room in double bottom
