# **Debrief Summary**

## **Joint Pollution Response Training**

**Homer, Alaska**

**April 23-27, 2001**

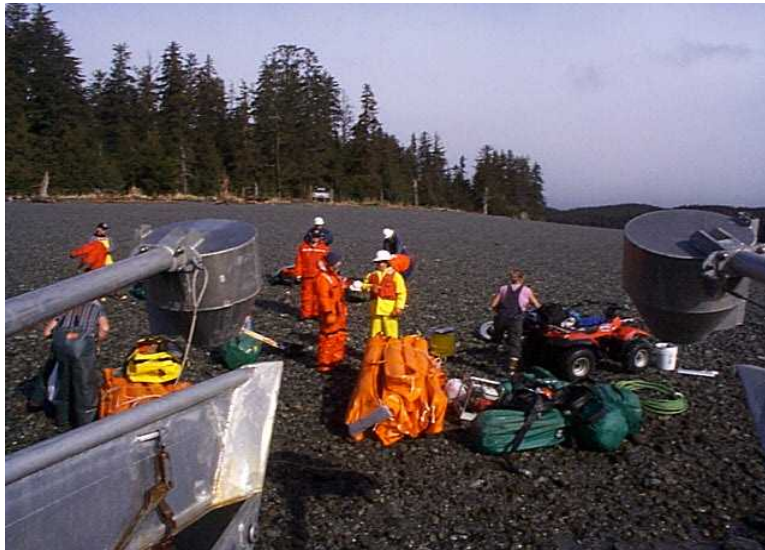
Group 1: Unloads equipment for boom deployment on Hesketh Island. Day 1

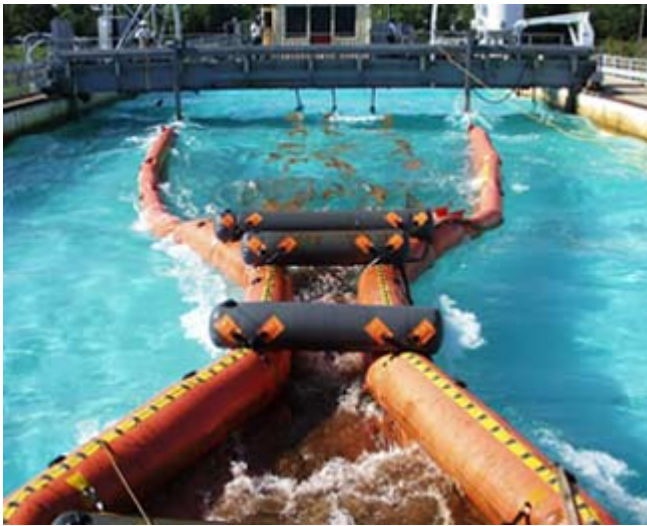
- Observation: The "current buster" skimming system was quick to deploy, and easily maneuvered and operated by readily available FVs with minimal guidance. The system requires 3 vessels: 2 tow vessels and a skimming vessel. The skimming vessel comes alongside, attaches to the boom, and lowers the skimmer into the "pocket" to collect oil. The currents running alongside the boom are very favorable to mooring the skimming vessel. Towing speeds varied from 1.5-3 kts, but the inside of the collection pocket was calm and provided excellent oil recovery conditions. Even during afternoon windy conditions with 3ft chop, the surface condition in the pocket remained much calmer and capable of collecting oil. One vessel should be designated as team leader to control the overall speed and direction of the team. The boom is easily towed to the scene by towing from the apex of the boom and trailing the leading ends.

Current Buster shown during trials at OHMSETT testing facility.

Recommendation: The "current buster" was easy to deploy and operate in the near shore environment. Training requirements are minimal, and the system works effectively in currents up to 3.5-4 knots. Continue to use the system in a wide variety of training environments to maximize the exposure and training to a large audience of potential users

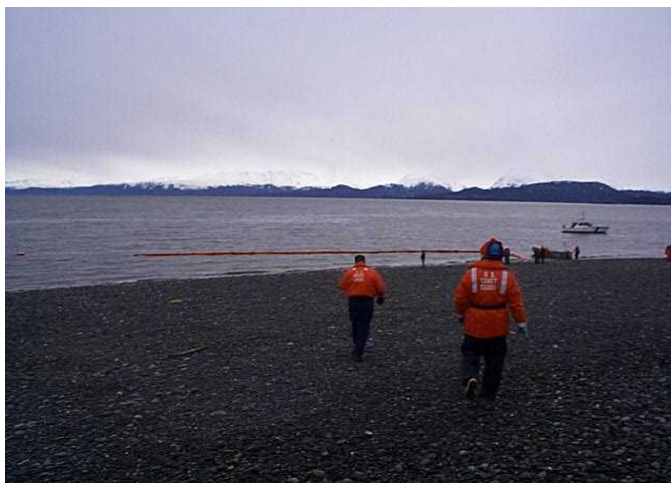
- Observation: The “Boom Vane” was initially deployed from the beach between the Lands End Hotel and the ferry pier. The vane was deployed on the last two hours of the ebb tide with an onshore wind of 15-20 kts. The current was estimated at less than 1.5 knots. Under these conditions, the vane performed marginally. The currents were not strong enough to overcome the on shore winds. Once the current dropped below 1.5 knots, the vane failed. The deployment site was then moved to attempt to locate a good site for the flood tide currents. Unfortunately, the site selected in front of the Lands End Hotel did not provide a good steady current greater than 1 kt, and the “vane” did not perform.  
Recommendation: Continue to expand and experiment with new types of technology in different situations to gain valuable experience in its use and limitations.

Boom Vane Deployment:  
Homer Spit.  
Day 2

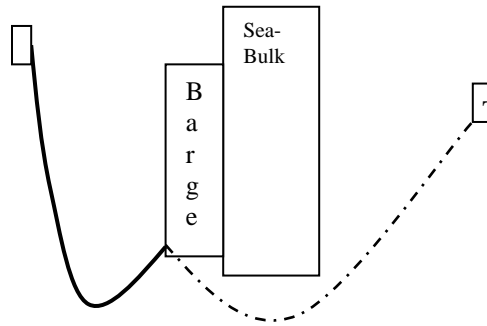
- Observation: The diagram above illustrates two different skimming deployments from the SEABULK MONTANA and Barge CISPRI RESPONDER using 1000' of Ro-Boom. The dotted line deployment was difficult to accomplish with the tow vessel available. The weight and drag of the boom in this configuration was too large for the tow vessel to overcome. The solid line deployment worked well using the same equipment.  
Recommendation: Continue to use this training as an opportunity to experiment with different techniques and equipment to determine which works best.

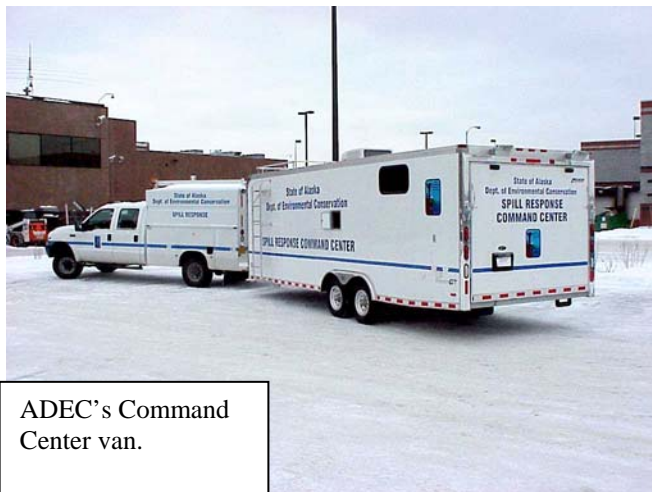
ADEC provided command post radio communications using their new mobile command post. The mobile command post is a self-contained 24' trailer powered by 2 household batteries and/or 2 separate generators. The trailer was towed to Homer using ADEC's ¾ ton truck, and was set up in under an hour with just 2 personnel. The trailer is equipped with CB radio, marine VHF, State VHF, air band radios, cell phone antennas, heater, fax, scanner, printer and copier. The walls are "white board" and space is available for small meetings without disruption to radio operators.

- Observation: ADEC's self contained mobile command trailer and the experience of ADEC radio operators worked well.  
Recommendation: Continue to task ADEC with communications responsibilities for exercises and actual incidents.

ADEC's Command Center van.

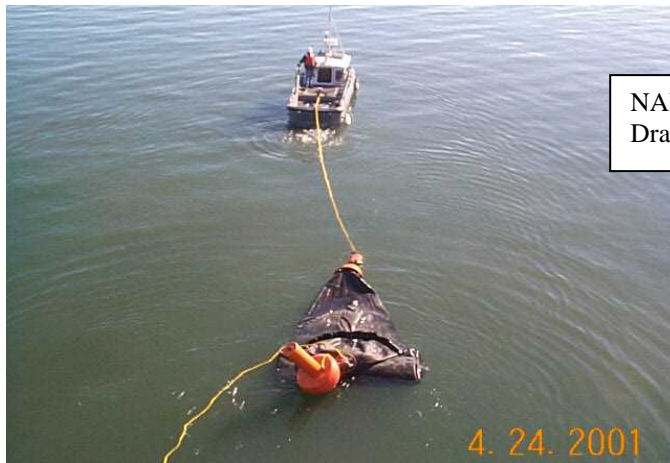
NAVSUPSALV deploys  
Dracone.
