M/V LECONTE UNIFIED COMMAND AFTER ACTION REPORT

Unified Command
After Action Report

M/V LECONTE Response

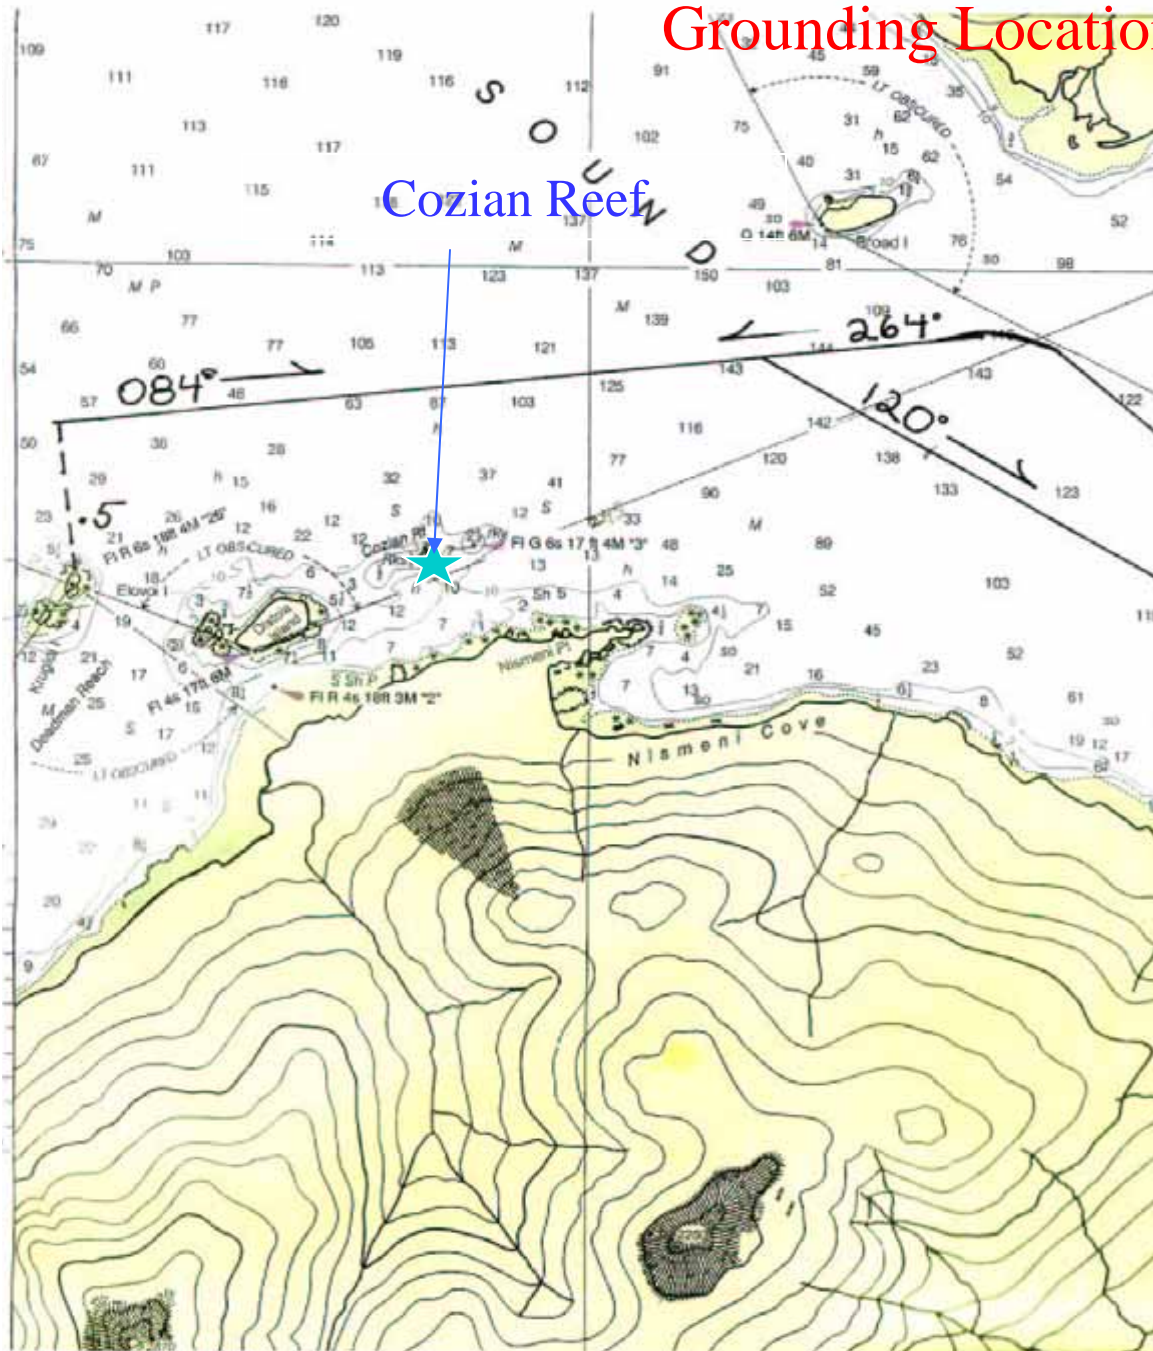
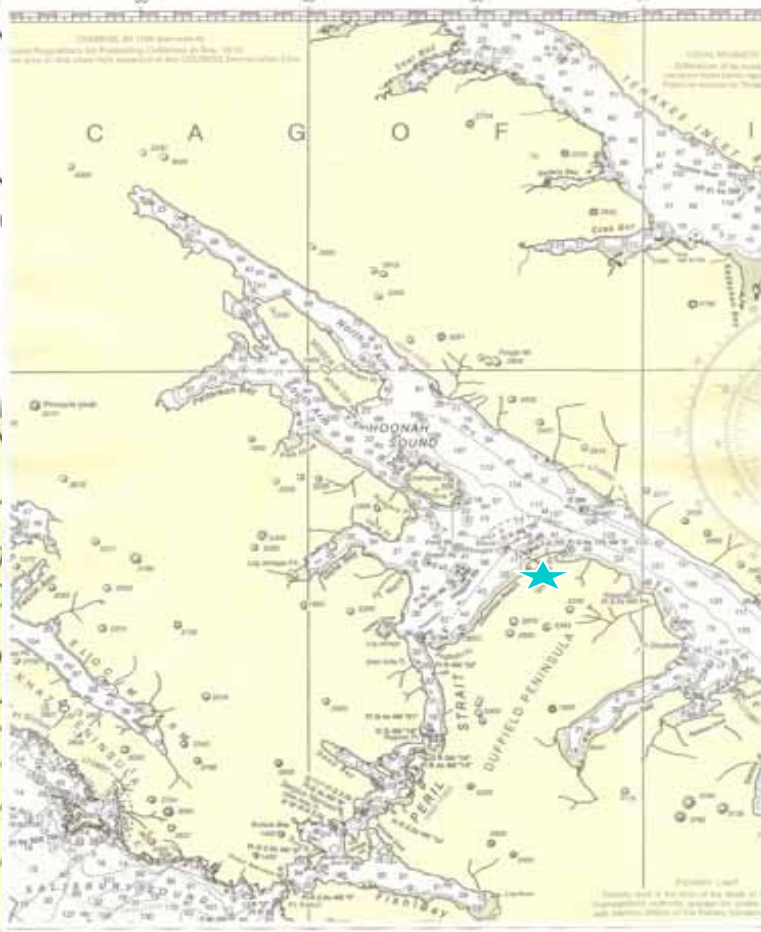
Grounding Location

- May 10, 2004
Alaska Marine Highway System (AMHS) vessel M/V LECONTE grounded on Cozain Reef in Peril Strait.
- Vessel reported flooding in five areas—two outer voids, bow thruster room, MSD space, and ballast tank.
- Command post was established at MSO Juneau . AMHS, ADEC, and MSO Juneau established a Unified Command and jointly staffed the command post.
- AMHS activated their contract with Alaska Steamship Response (ASR) to assist with response management, and with SEAPRO to support both command post requirements and to provide on scene pollution response capability.

Cozian Reef

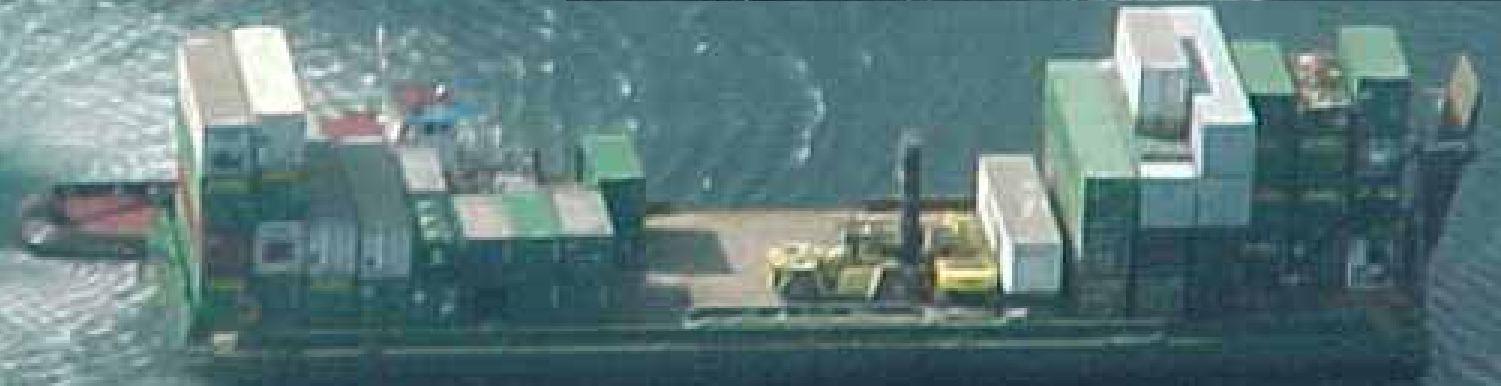
Tug Western Mariner with Container Barge
Stood by following grounding & assisted with evacuation

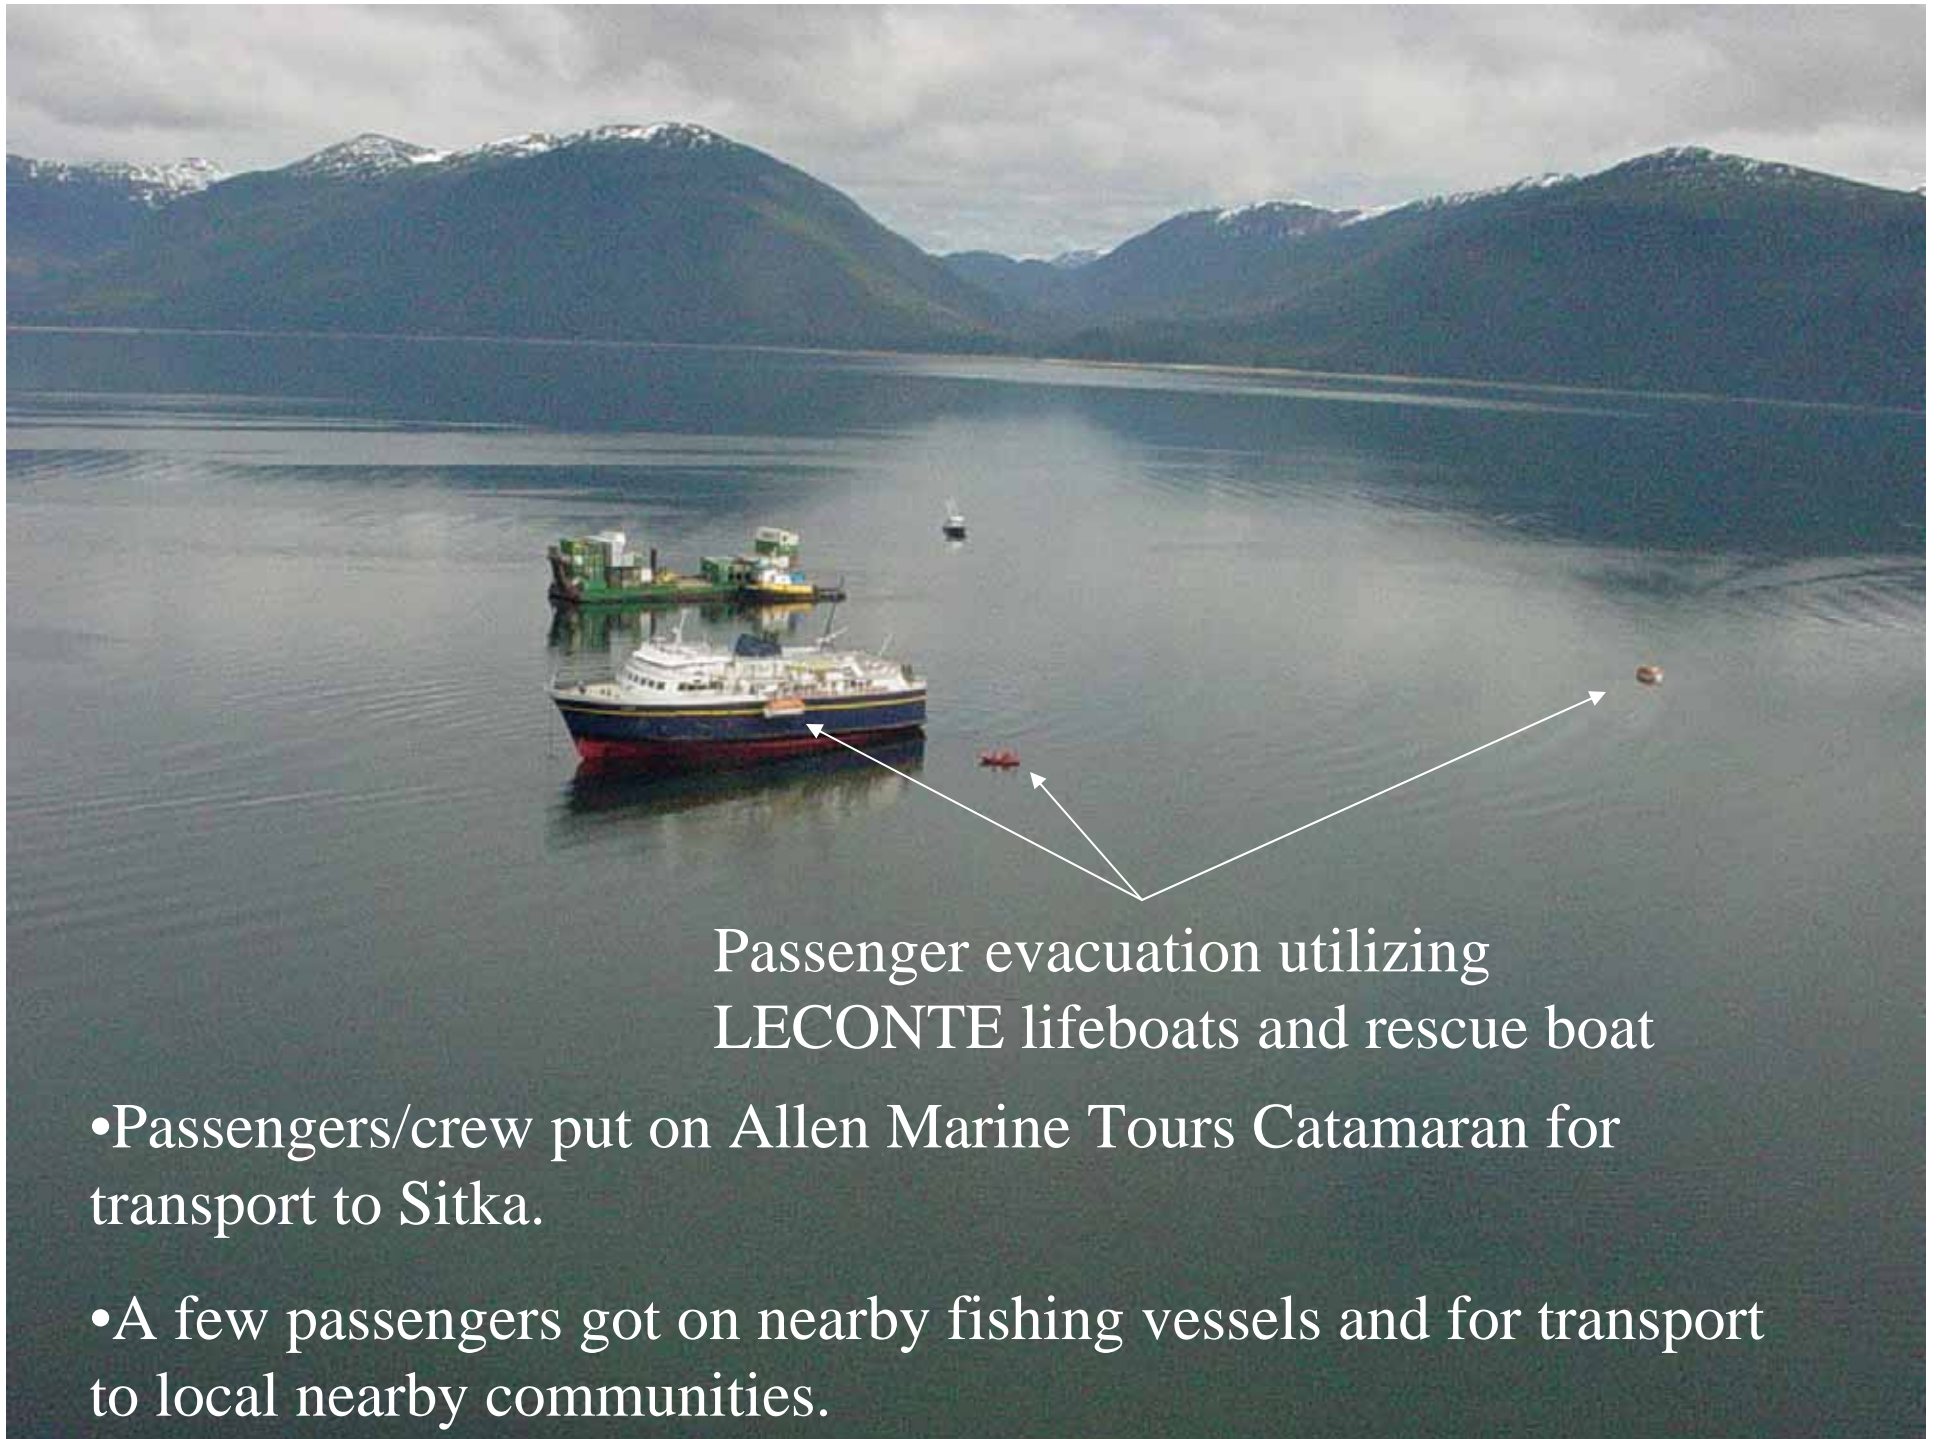
Passenger evacuation utilizing
LECONTE lifeboats and rescue boat

- Passengers/crew put on Allen Marine Tours Catamaran for transport to Sitka.
- A few passengers got on nearby fishing vessels and for transport to local nearby communities.

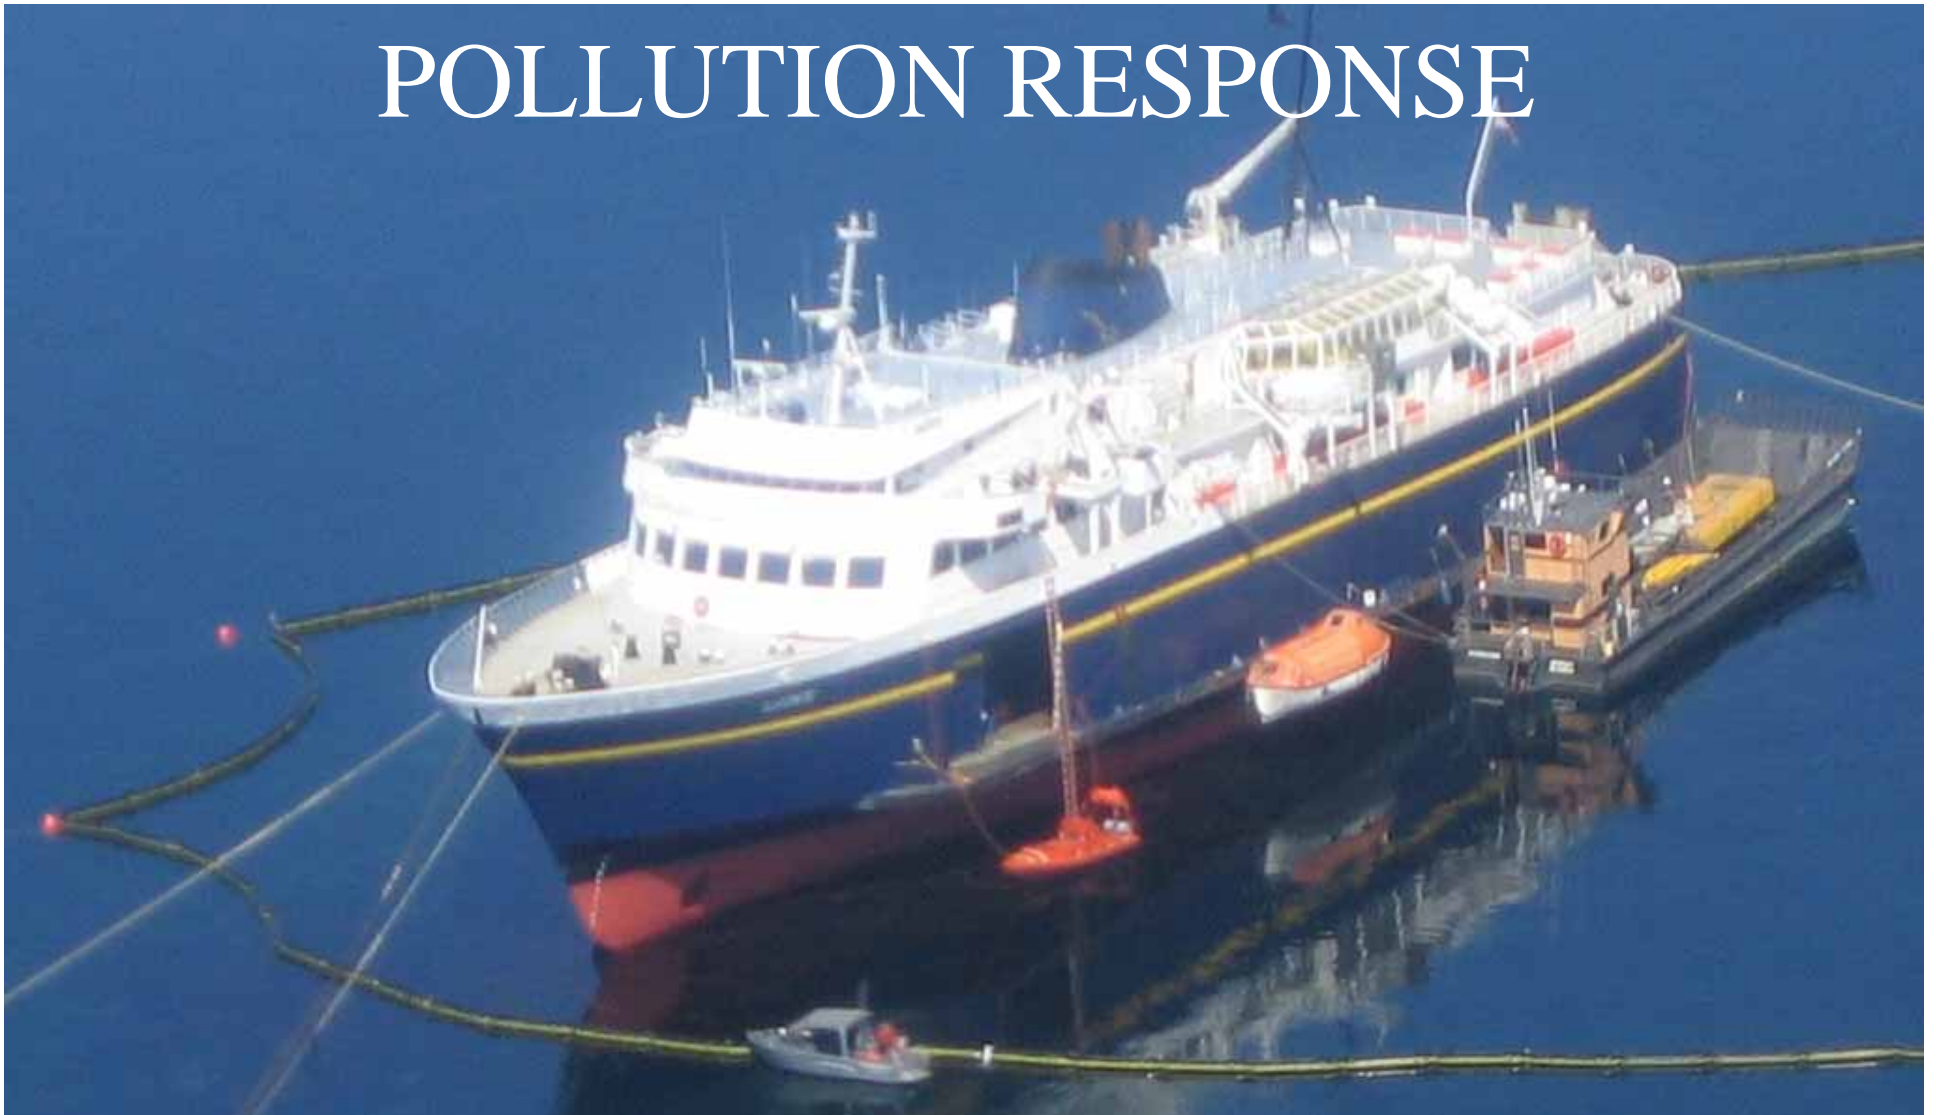
POLLUTION RESPONSE

- Vessel surrounded by boom - approximately 1000 ft
- Vehicles removed from ferry onto Landing Craft
- Fuel Lightered to Landing Craft – approximately 23,000 Gallons

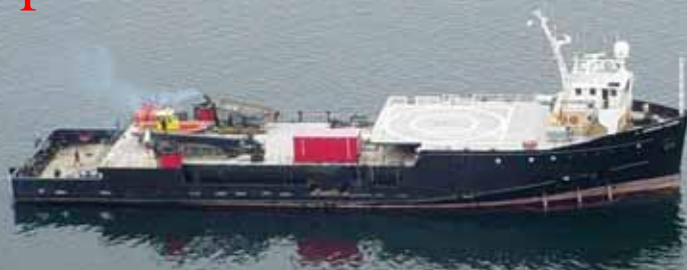
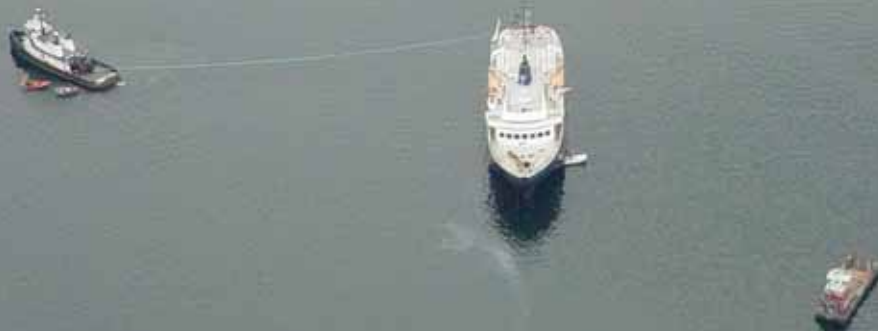
SALVAGE OPERATIONS

Salvage planning was initiated by AMHS early which was critical to response.

- Weather was excellent for 2 week period of operations
- Tow Plan Developed
- Determined Places of Safe Refuge along tow route
- Trustees provided historical properties and critical habitats information for tow route
- Crowley Salvors completed temporary repairs and utilized “air bubble” in holed tanks to keep LECONTE afloat after removal from the reef.

90,000 lbs of steel replaced
